# SERVICE BULLETIN NO. MSB-AE50R-003

Engine affected: **AE50R Series**

Sub Assembly Rotor & Pulley – R1A-91-100-000 (E\_R1 B 034)

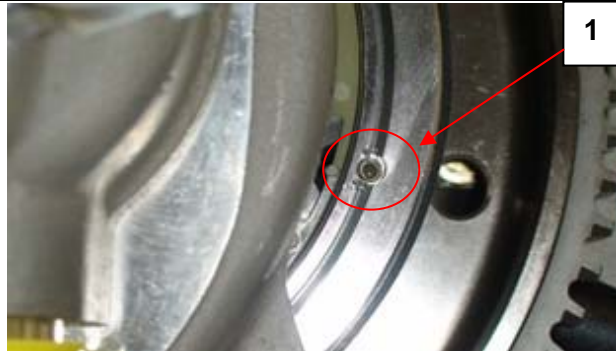
- ⇒ Identify if a twist between the belt pulley and the rotor is evident or grub screws got loose [Figure 1] or are missing.

Figure 1: Scrub screw assembly

- ⇒ Remove all grub screws [Figure 1] in the generator rotor assembly.
- ⇒ Clean the holes with ACETON, use new scrub screws M4x5 (DIN 913).
- ⇒ Screw in the grub screws as far as possible.
- ⇒ The new scrub screws are 3mm shorter than the original assembled scrub screws. Use LOCTITE "Hysol" 3450 two component epoxy adhesive. Fill the thread above the scrub screw consistent with the adhesive to avoid unbalanced mass during operation [Figure 3]. Make sure that the adhesive enters the thread and cured according the product description sheet before operation.
- ⇒ Remove overlapping adhesive.
- ⇒ Clean the working area.

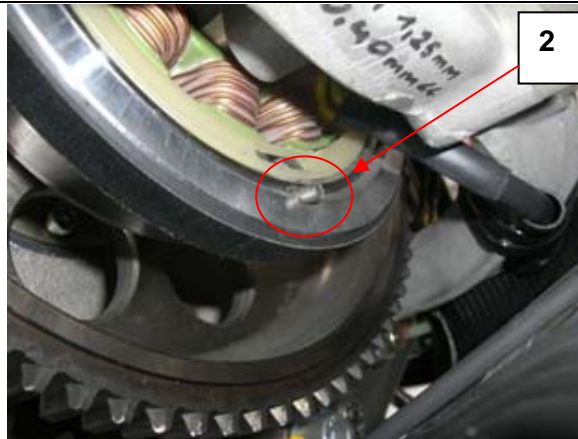
During scheduled maintenance on some engines without grub screws relative movement between belt pulley and rotor was identified. In addition some grub screws came loose on engines with grub screws installed.

Figure 2: Loose scrub screws

If the grub screws are missing or not properly screwed the following maintenance action is required:

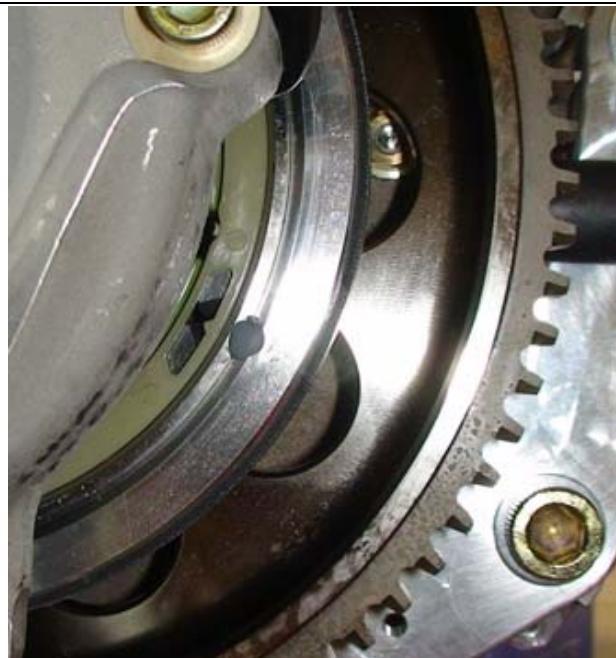
Figure 3: Rework solution with LOCTITE "Hysol" 3450

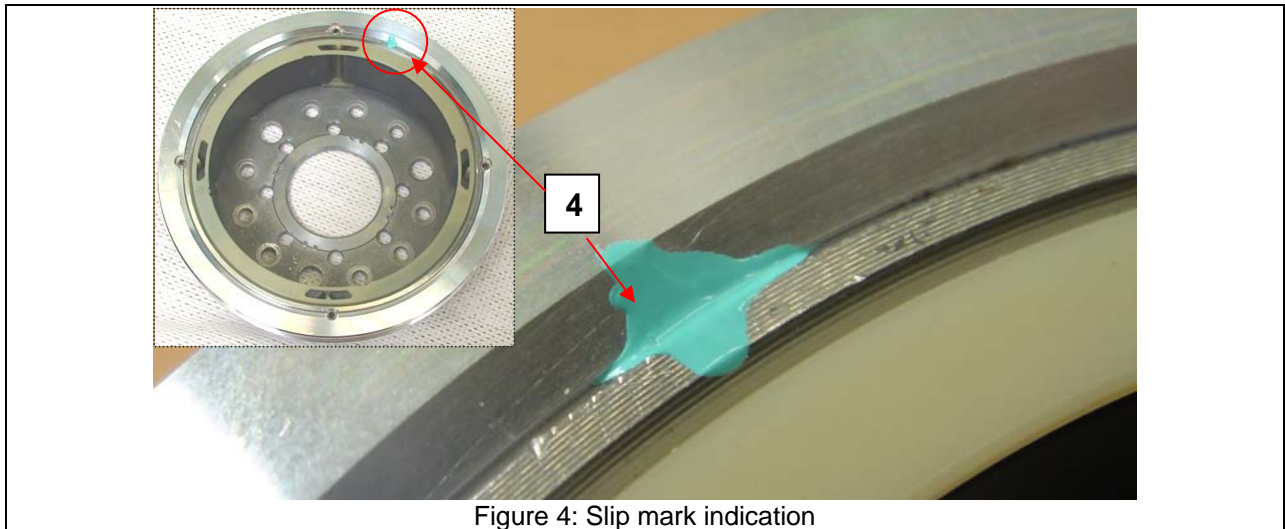
Figure 4: Slip mark indication

- ⇒ Identify if a twist between the belt pulley and the rotor is verifiable evident.
- ⇒ If no movement has been identified apply an adequate slip mark [Figure 4] on the visible belt pulley and rotor surface to monitor possible movement during operation.

It is required to monitor the slip mark during scheduled maintenance to identify possible movement between the belt pulley and the rotor.

If movement has been identified the engine needs to be disassembled and sent back to Diamond Aircraft GmbH (Diamond Engines) for replacement of the parts.
